Manhole Inspection Summary

Manhole # S17EE2033MH

Location Address: **1718 SULGRAVE AVE**

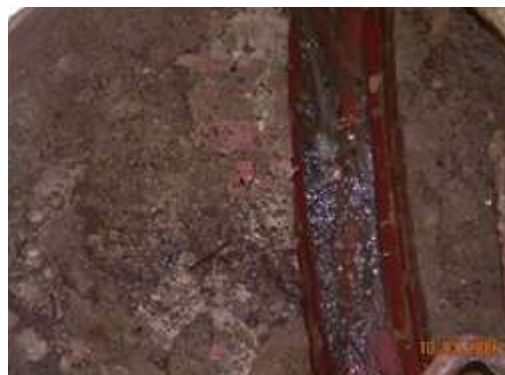
Top View

Corroded steps. Evidence of surcharge - Bench debris. Channel debris.

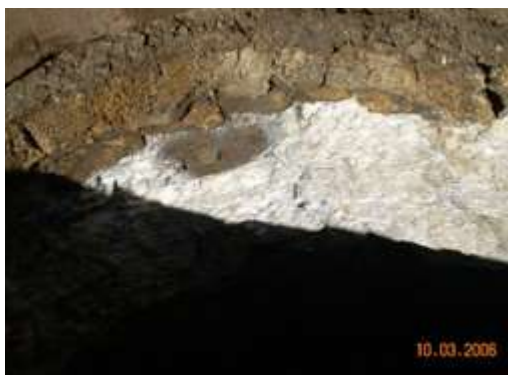
Defect

Adjustment deterioration and infiltration. Mineral deposits.

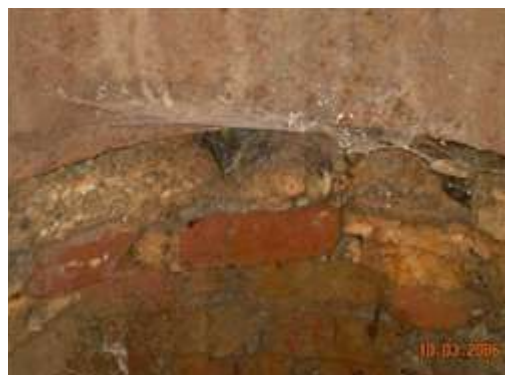
Defect

Adjustment deterioration and infiltration. Corbel infiltration.

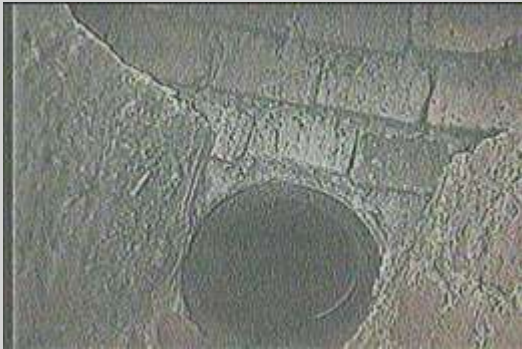
8 in. Circular Gravity Sewer Pipe Out @ 12 O'Clock

Infiltration: **Evidence** Pipe Seal Cond: **Unknown**

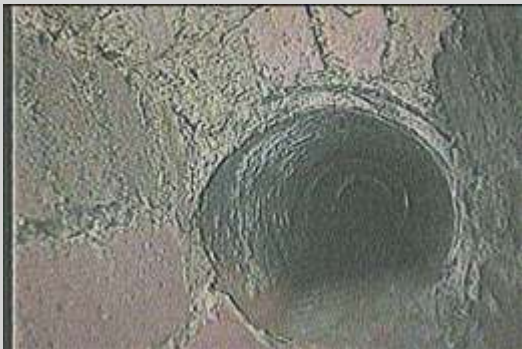
8 in. Circular Gravity Sewer Pipe In @ 6 O'Clock

Infiltration: **Evidence** Pipe Seal Cond: **Unknown**
